**DEPARTMENT OF TRANSPORTATION****DIVISION OF ENGINEERING SERVICES**

Contract #: 04-0120F4Cty: SF/ALA Rte: 80 PM: 13.2/13.9File #: 13.28**WELDING INSPECTION REPORT****Resident Engineer:**Pursell, Gary**Address:** 333 Burma Road**City:** Oakland, CA 94607**Report No:** WIR-006140**Date Inspected:** 09-Apr-2009**Project Name:** SAS Superstructure**OSM Arrival Time:** 700**Prime Contractor:** American Bridge/Fluor Enterprises, a JV**OSM Departure Time:** 1530**Contractor:** Oregon Iron Works Clackamas, Or.**Location:** Clackamas, OR**CWI Name:** Mike Gregson, Rob Walters**CWI Present:** Yes No**Inspected CWI report:** Yes No N/A**Rod Oven in Use:** Yes No N/A**Electrode to specification:** Yes No N/A**Weld Procedures Followed:** Yes No N/A**Qualified Welders:** Yes No N/A**Verified Joint Fit-up:** Yes No N/A**Approved Drawings:** Yes No N/A**Approved WPS:** Yes No N/A**Delayed / Cancelled:** Yes No N/A**Bridge No:** 34-0006**Component:** Hinge K Pipe Beams**Summary of Items Observed:**

**Hinge-K Pipe Beam Fuse Assembly 120A-1:****a125 Stiffener Ring Weld Repairs**

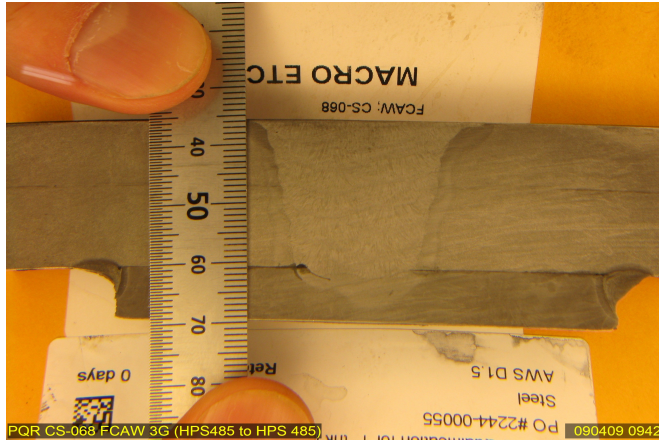
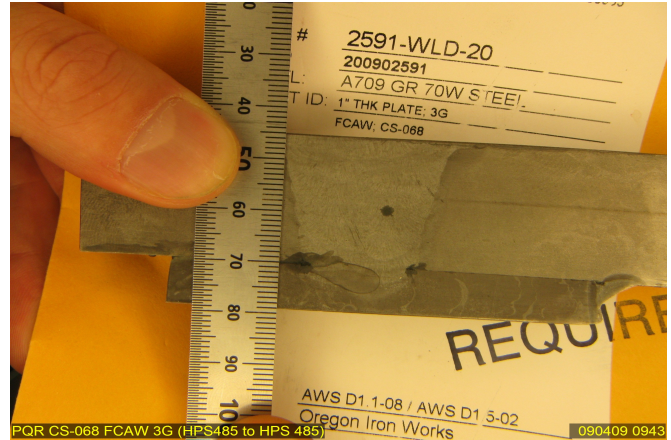
#### PQR #CS-068

QA Inspector noted that Acuren Inspection personell performed 100% radiograph inspection (RT) on this PQR CS-068 test plate and notified QA Inspector Clete Henke and OIW QC Manager Tom Tomovik that this PQR test plate did not pass RT, due to lack of penetration at the weld root pass. QA Inspector Clete Henke arrived at Acuren Inspection testing laboratories to review the RT film images and agreed with the Koon-Hall-Adrian Metallurgical pesonell, that this was a lack of weld fusion at the root pass.

QA Inspector noted that QC Manager Tom Tomovik had arrived at Acuren Inspection Laboratories on 4/6/09 to also review the RT film and two end cut test samples on this PQR CS-068 and stated that this particular discontinuity was internal undercut and not a lack of penetration at the weld root pass. After further review with Acuren Inspection Testing personell, it was mutually agreed upon that this was acceptable internal undercut (less than 1mm deep).

QA Inspector noted that additional macro etch test samples were to be cut and applicable destructive testing was to be performed on this PQR test plate by Koon-Hall-Adrian Metallurgical personell on 4/10/09. QA Inspector arrived at Koon-Hall-Adrian Metallurgical on 4/10/09 and was informed by Koon-Hall-Adrian Metallurgical personell that the PQR macro etch test samples were acceptable, per AWS D1.5 standards. QA Inspector witnessed the cut macro etch test samples, measured the internal discontinuities to be less than 1mm deep and took digital photographs, as shown below.....

QA Inspector notified QC Manager Tom Tomovik that a request for information (RFI) should be submitted, addressing this issue and QA Inspector noted that this RFI has not been submitted by OIW and is still currently pending.
